MARINE SAFETY ALERT

Alert 09-10

TYPE I PERSONAL FLOTATION DEVICE STRAP CHECK

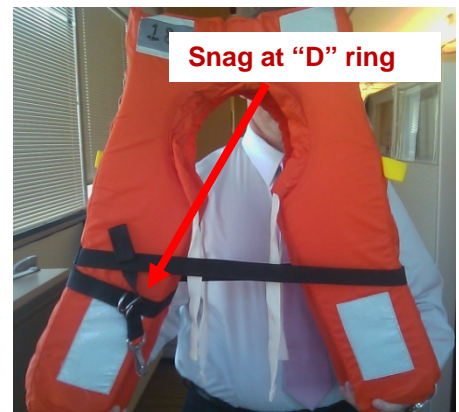
Instead of the strap falling away, allowing the wearer to wrap it around him or her, the clip end of the strap could snag in the "D" ring preventing the wearer from getting it around their body. *(Following image)*

The Coast Guard **strongly recommends** that vessel owners/operators using the PFDs listed above check each lifejacket for proper routing of the strap. Completely unwrap the primary strap to ensure it is free and capable of being adjusted for any wearer. The strap of the lifejacket must not be threaded through the fixed "D" ring. If routing is satisfactory, the strap may be wrapped around the life jacket and clipped to the fixed "D" ring for storage. *(Right image)* If the strap is incorrectly threaded through the fixed "D" ring, the snap hook assembly should be carefully removed from the strap, the strap pulled out of the fixed "D" ring, and the snap hook assembly re-attached.

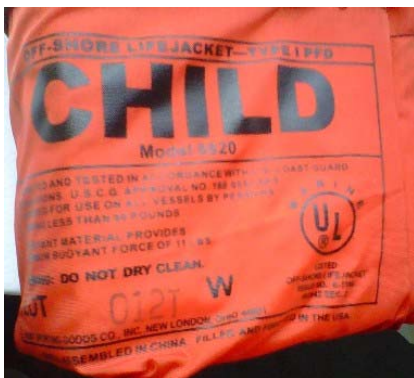
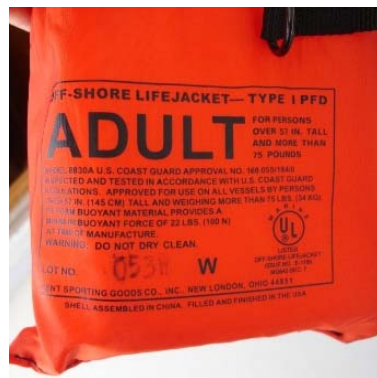
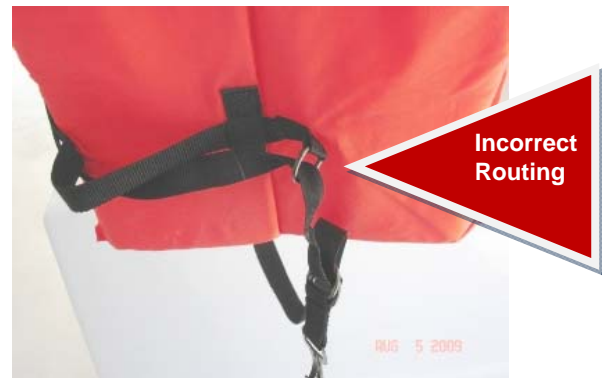
Kent Sporting Goods Lifejackets Shown Above

Kent Adult Model 8830 (USCG Approval Number 160.055/184/0) in Lot 53W manufactured in October 2006

Kent Child Model 8820 (USCG Approval Number 160.055/150/0) in Lot 012T manufactured in March 2008
