# CALIFORNIA CLEAN VESSEL ACT PUMPOUT AND DUMP STATION PERFORMANCE REPORT 2023

This California Clean Vessel Act Pumpout and Dump Station Performance Report highlights findings on the condition and operational status of pumpout and dump stations during 2023. Discharging sewage overboard creates environmental and human health problems, especially in California, a state with more than four million recreational boaters. To reduce the negative impacts of discharging sewage overboard, all boaters are encouraged to use sewage management facilities such as pumpout stations, dump stations, floating restrooms, and mobile pumpout services.

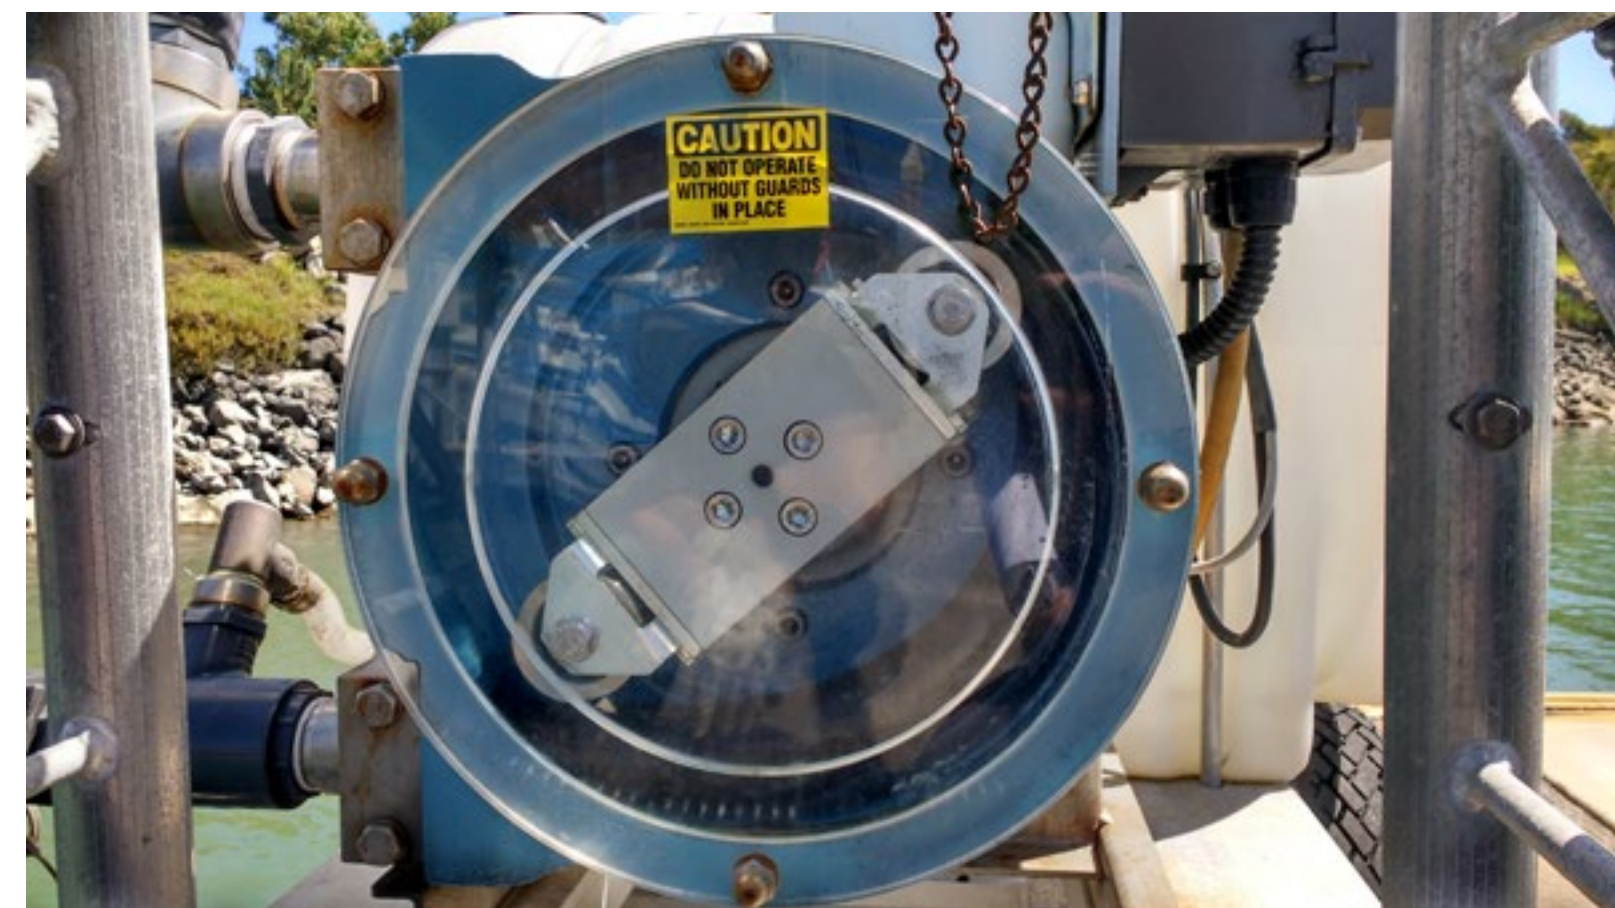
Peristaltic pump Photo by TBF

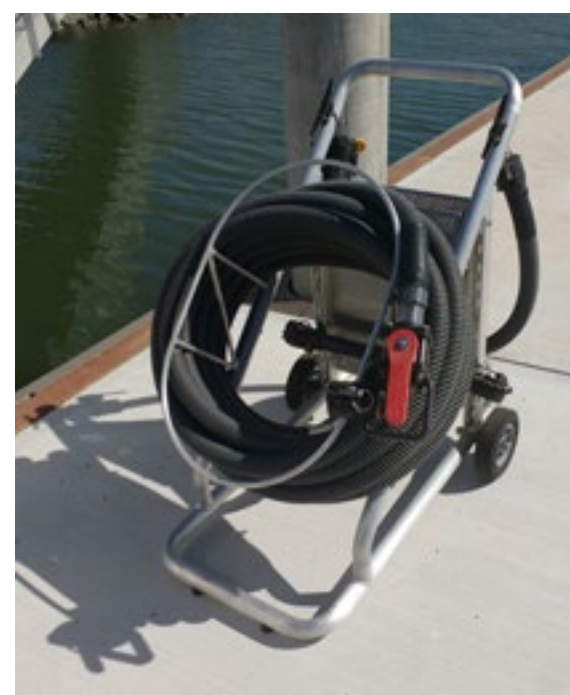
In-slip hose cart at Westpoint Harbor  
Photo by SFEP

**Option 1:** The marina installs a centralized pumpout station with multiple pumpout hydrants located throughout the marina, and spaced (approximately 40 feet to 60 feet apart) so that a portable hose can reach from the hydrant, located on the dock, to each nearby vessel. The pumpout hose is mounted on a mobile cart. The cart with the hose is wheeled to each boat as it needs pumpout servicing. The hose is unreeled and connected to both the hydrant and boat to be serviced. Wireless transmitters are available that allow convenient on-off operation without the need for someone to run back to the pump each time it needs activating.

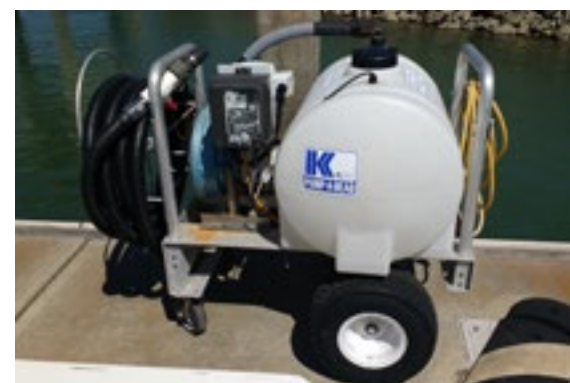
In-slip pumpout tank at Oyster Cove Marina  
Photo by SFEP

**Option 2:** The marina installs multiple pumpout hydrants throughout the marina, spaced so that a portable hose can reach from the hydrant to each nearby vessel. A mobile cart containing both a sewage pump and hose is then wheeled to each boat as it needs pumpout servicing. The hose is unreeled and connected to both the hydrant and boat to be serviced. The sewage pump is activated and uses the hydrant and piping system to discharge the boat's holding tank contents.

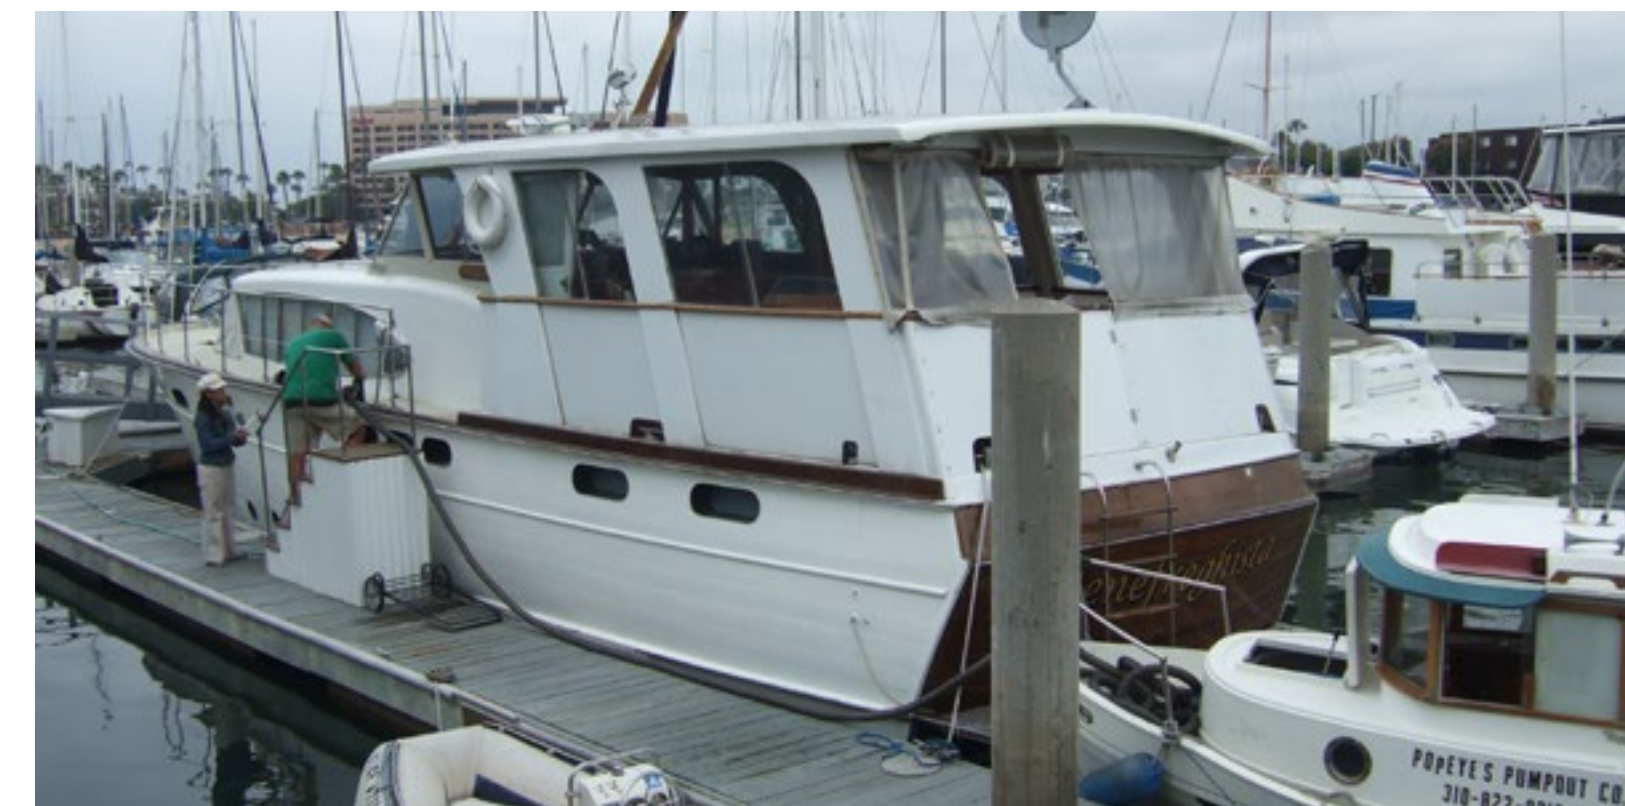
In many areas of California, boaters can have their boat sewage removed by a [mobile service](#). Mobile service vessels are retrofitted to hold a large quantity of sewage and can typically pump out dozens of vessels before having to discharge into a dockside pumpout system. This service can be managed by a contractor or provided by the marina itself, or simply allowed on premises as a boater-solicited service.

Mobile pumpout service in Marina del Rey Harbor  
Photo by TBF

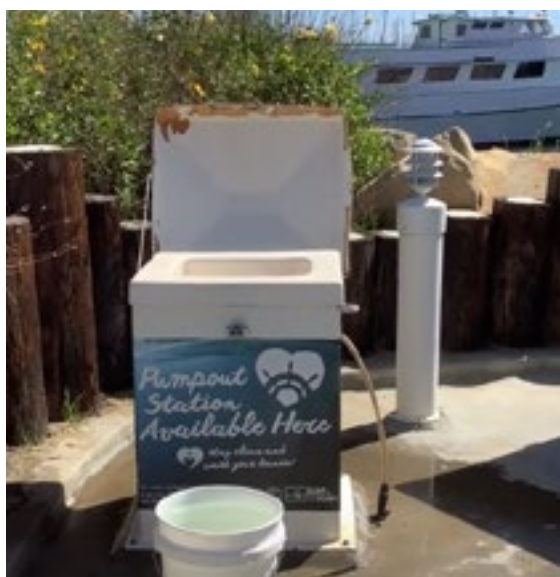
Gravity-drained dump station in Santa Barbara Harbor  
Photo by TBF

Some portable toilet dump stations are installed as stand-alone systems without a connection to a motor. These units are gravity-drained, also known as “gravity-fed”, and function through the force of gravity which pushes and drains sewage into an underground holding tank, which is often without sewer utility connections.

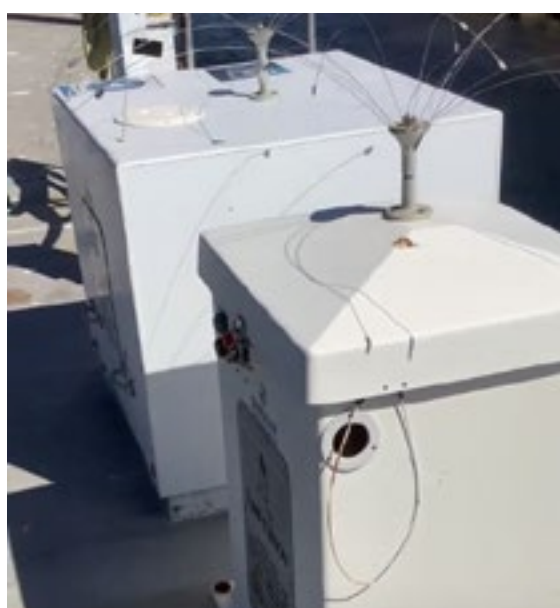
Dump station (right) installed at the point of service  
Photo by TBF

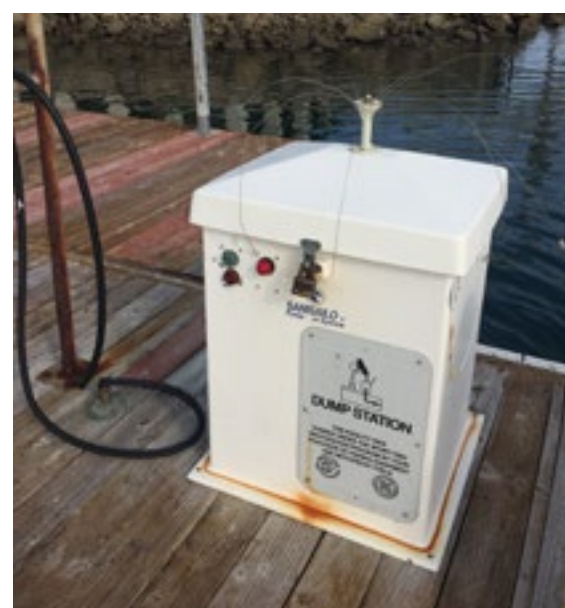
Dump station installed remotely from point of service  
Photo by TBF

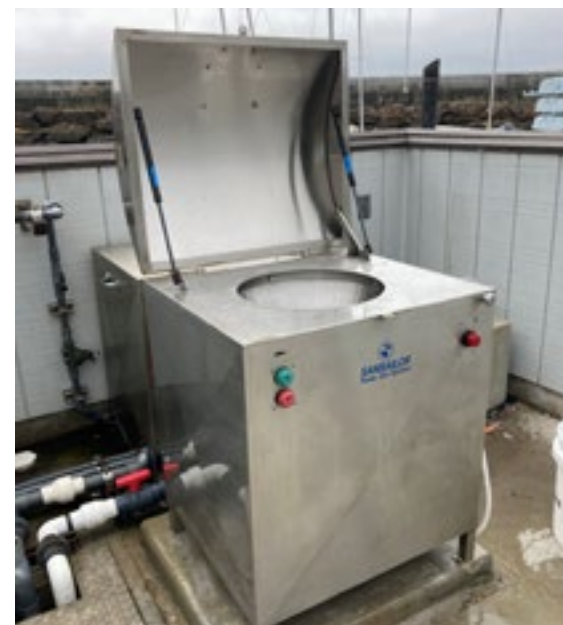
Motorized dump station  
Photo by TBF

There are several models of motorized dump stations that include electric parts in various degrees (such as ‘On’ and ‘Off’ switches, ejector pumps, auto-risers, electric ball valves, and sensory systems, etc.), and they can be connected to and powered by the pumpout station’s motor in a range of ways.

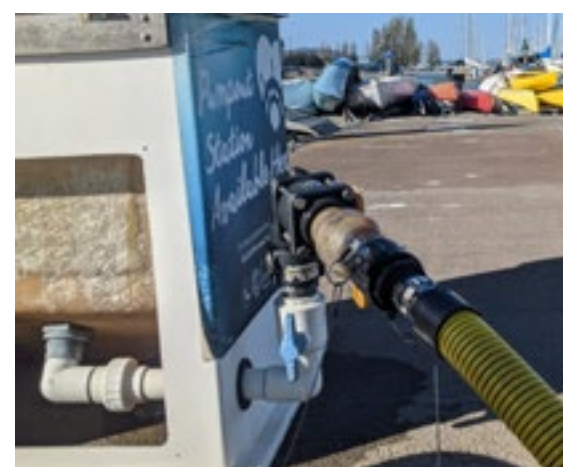
A gravity-drained dump station manually connected to a pumpout unit’s infrastructure by attaching the pumpout unit’s hose to the dump station waste fitting  
Photo by SFEP

Some dump stations are not directly connected to pumpout sewer lines or a motor but are still used in tandem with pumpout systems. To ensure contents are properly disposed of, these dump stations must be manually connected to a pumpout station’s infrastructure. The dump station’s contents are pumped out using a pumpout station’s parts and power. To accomplish this pumpout unit’s suction hose is connected to the dump station’s waste piping ball check valve to provide vacuum power and to pump out waste.

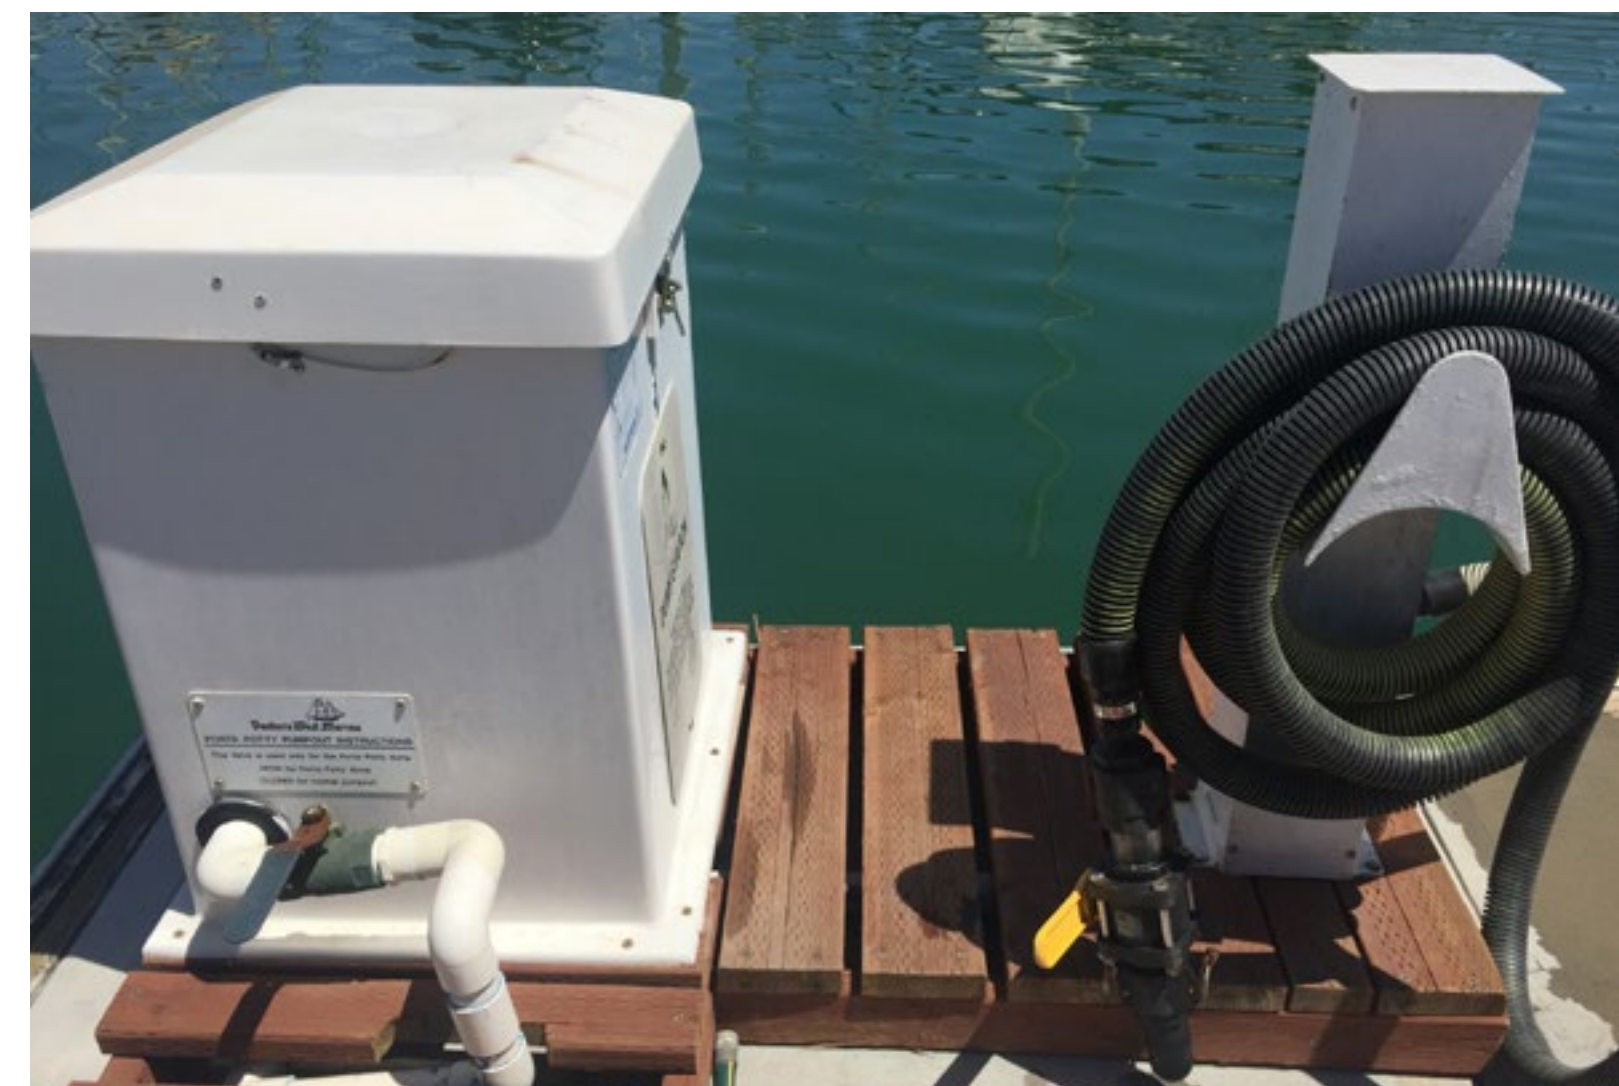
In some cases, a motorized dump station’s connection to a sewer line must be manually opened by utilizing a ball valve. This allows for pressure to enter the unit from the shared motor and for it to function remotely or at point of service.

Motorized dump station requiring the manual opening of its ball valve for drainage  
Photo by TBF

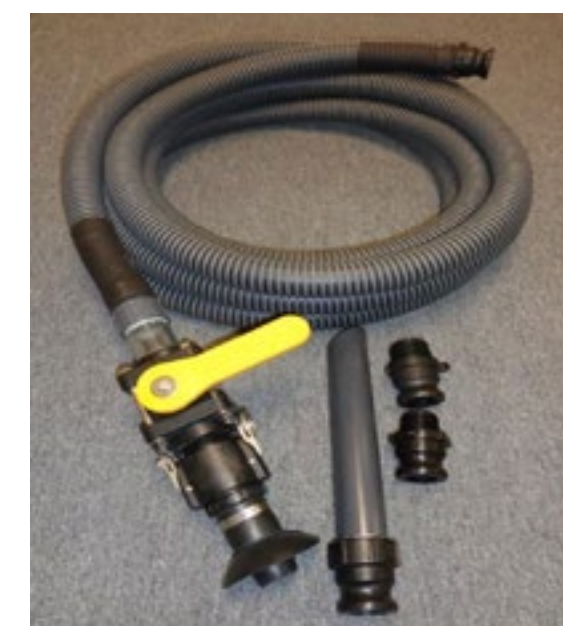
Although not technically a dump station, a pumpout wand functions to provide the same service that a dump station provides to boaters. Rather than installing a dump station, some marinas opt to retrofit their pre-existing pumpout units with a suction wand attachment. To do this, the pumpout unit’s nozzle is removed from the hose’s coupler and a suction wand is inserted in its place.

Pumpout wand attachment and supporting parts  
Photo by KECO Pump & Equipment

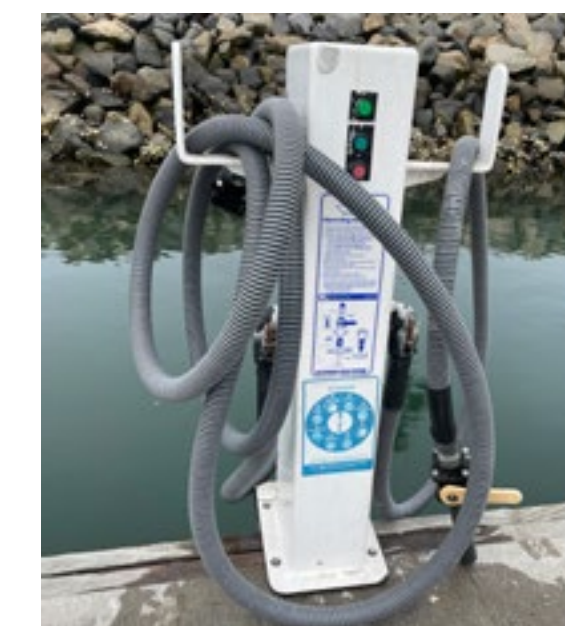
Pumpout unit retrofitted with a port-a-potty wand attachment  
Photo by TBF

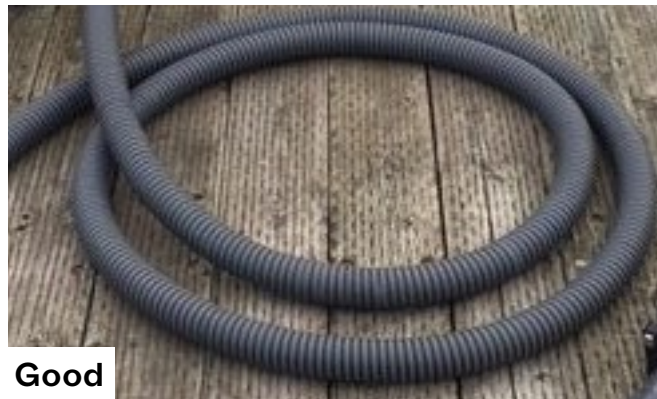
Good

Preventative maintenance is the best solution for avoiding problems. Marina operators should inspect the pump and pump enclosure on a weekly basis and, when possible, daily. These inspections should check for leaks, cracks, unusual wear and missing equipment.

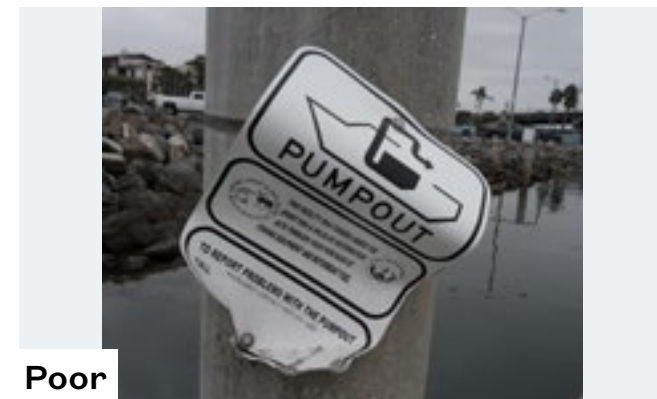
Poor

**HOSE**  
Look for damage that could affect performance of the system, like tears or a collapsed hose wall. To keep repair costs down, sections of hose can be repaired rather than replacing the entire hose. The number of repairs on one hose should be limited as performance will degrade over time.

**SIGHT GLASS**  
Look for cracks and make sure the movement of effluent is visible through the sight glass.

**NOZZLE**  
Look for signs of wear, including cracks and tears. Ensure that the tip has not been cut off and there is a backflow flap in place.

**BALL VALVE**  
Check that handles are not broken and can be easily rotated.

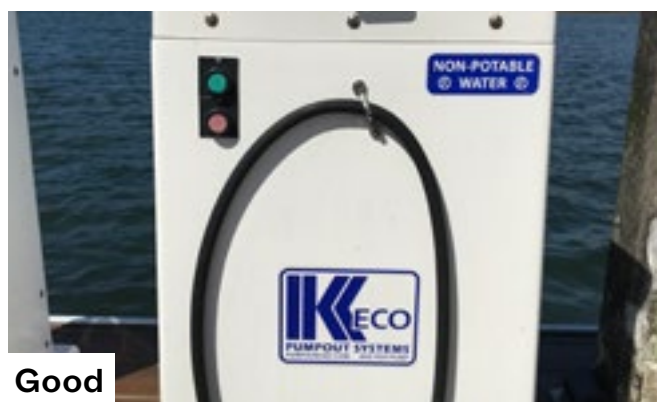
Good

Dump station maintenance is also key for ensuring consistent operation. These units are often connected to the same motor as a pumpout machine, so any issue seen with a dump station can be indicative of a larger problem. Marina operators should regularly inspect the hose connections and internal housing for wear and tear on the machine.

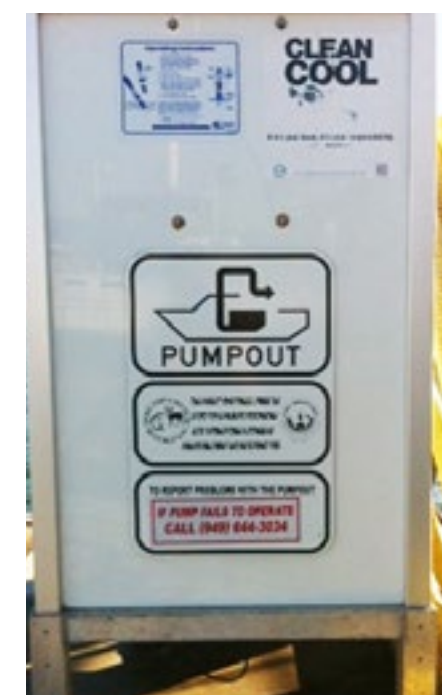
Signage in Balboa Yacht Basin  
Photo by TBF

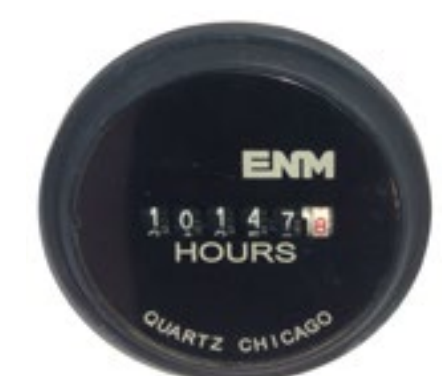
Hour counter  
Photo by TBF

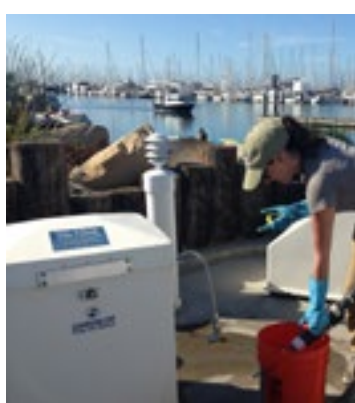
Vacuum time  
Photo by TBF

Vacuum time is another indication of how well the unit operates. During each monitoring event, this is measured by timing how long it takes a pumpout to evacuate five gallons of water. The optimum vacuum time is less than 10 seconds.

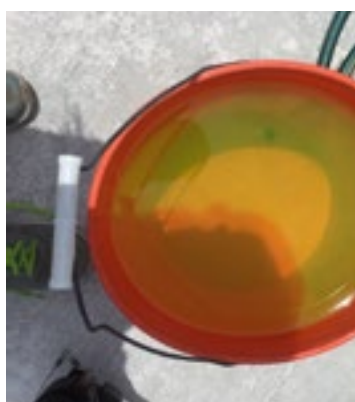
As a courtesy, Morro Bay National Estuary Program, San Francisco Estuary Partnership, and The Bay Foundation offer complimentary dye tablet testing. This test can help identify leaks in the plumbing of a sewage pumpout system. The results of this test are not presented in this report.

Dye tablet dissolving in 5 gallon bucket of water  
Photo by TBF

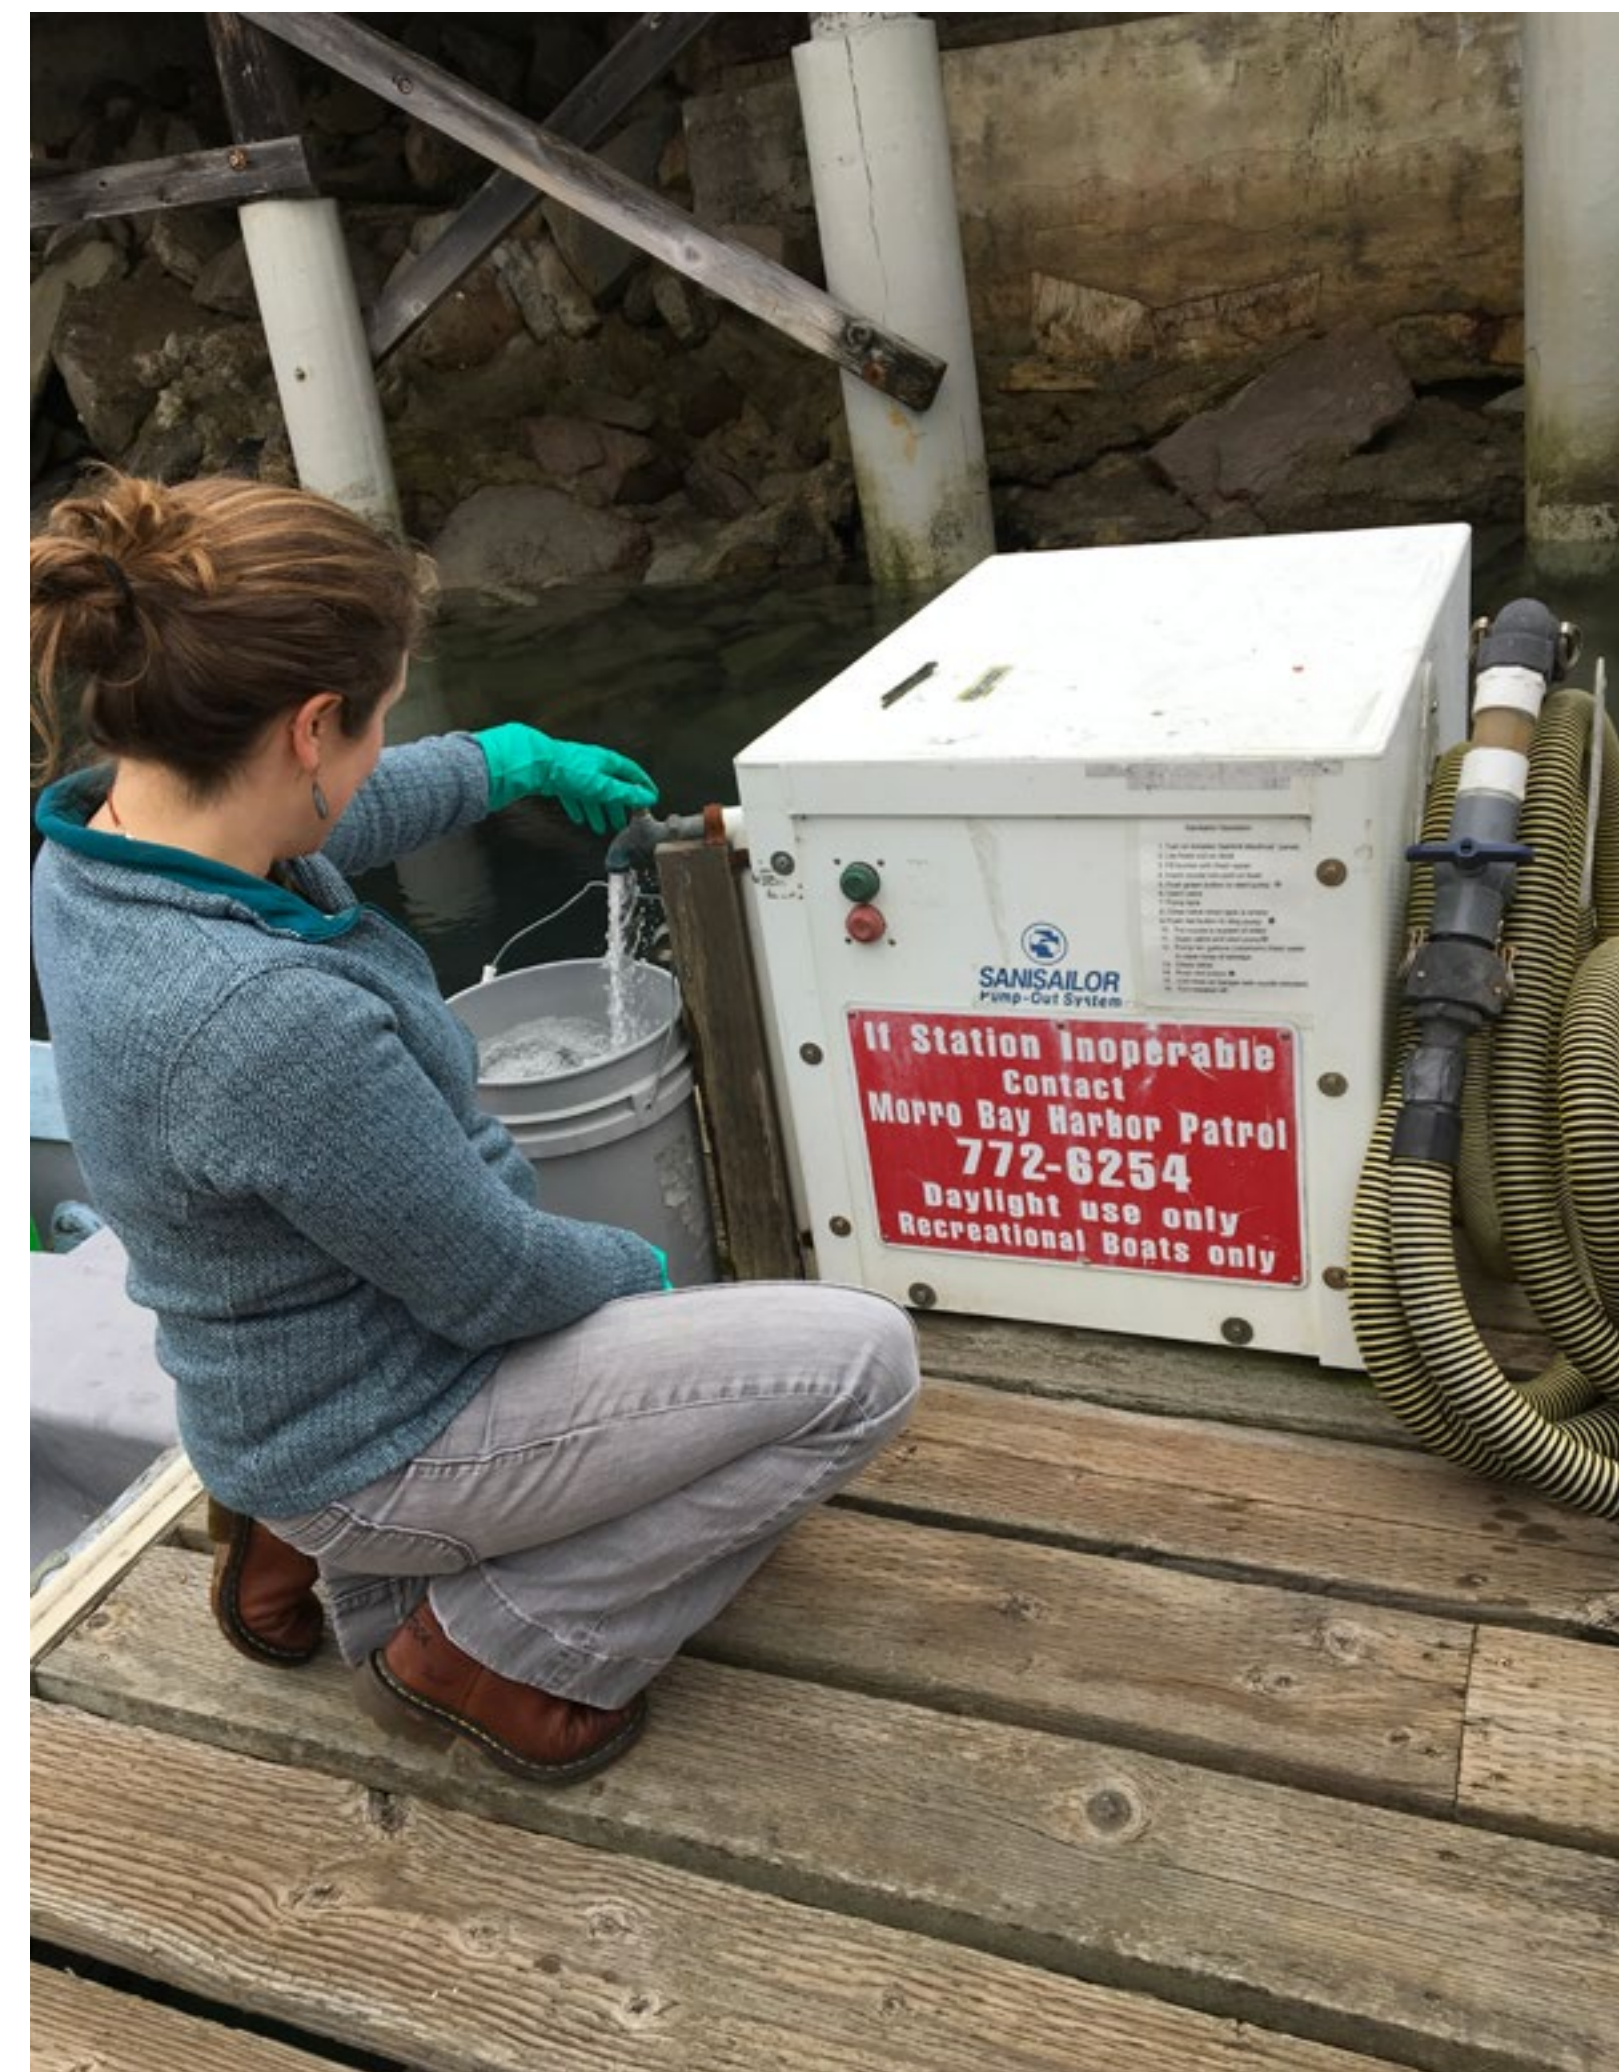
MBNEP staff filling 5-gallon bucket in order to test vacuum time  
Photo by MBNEP

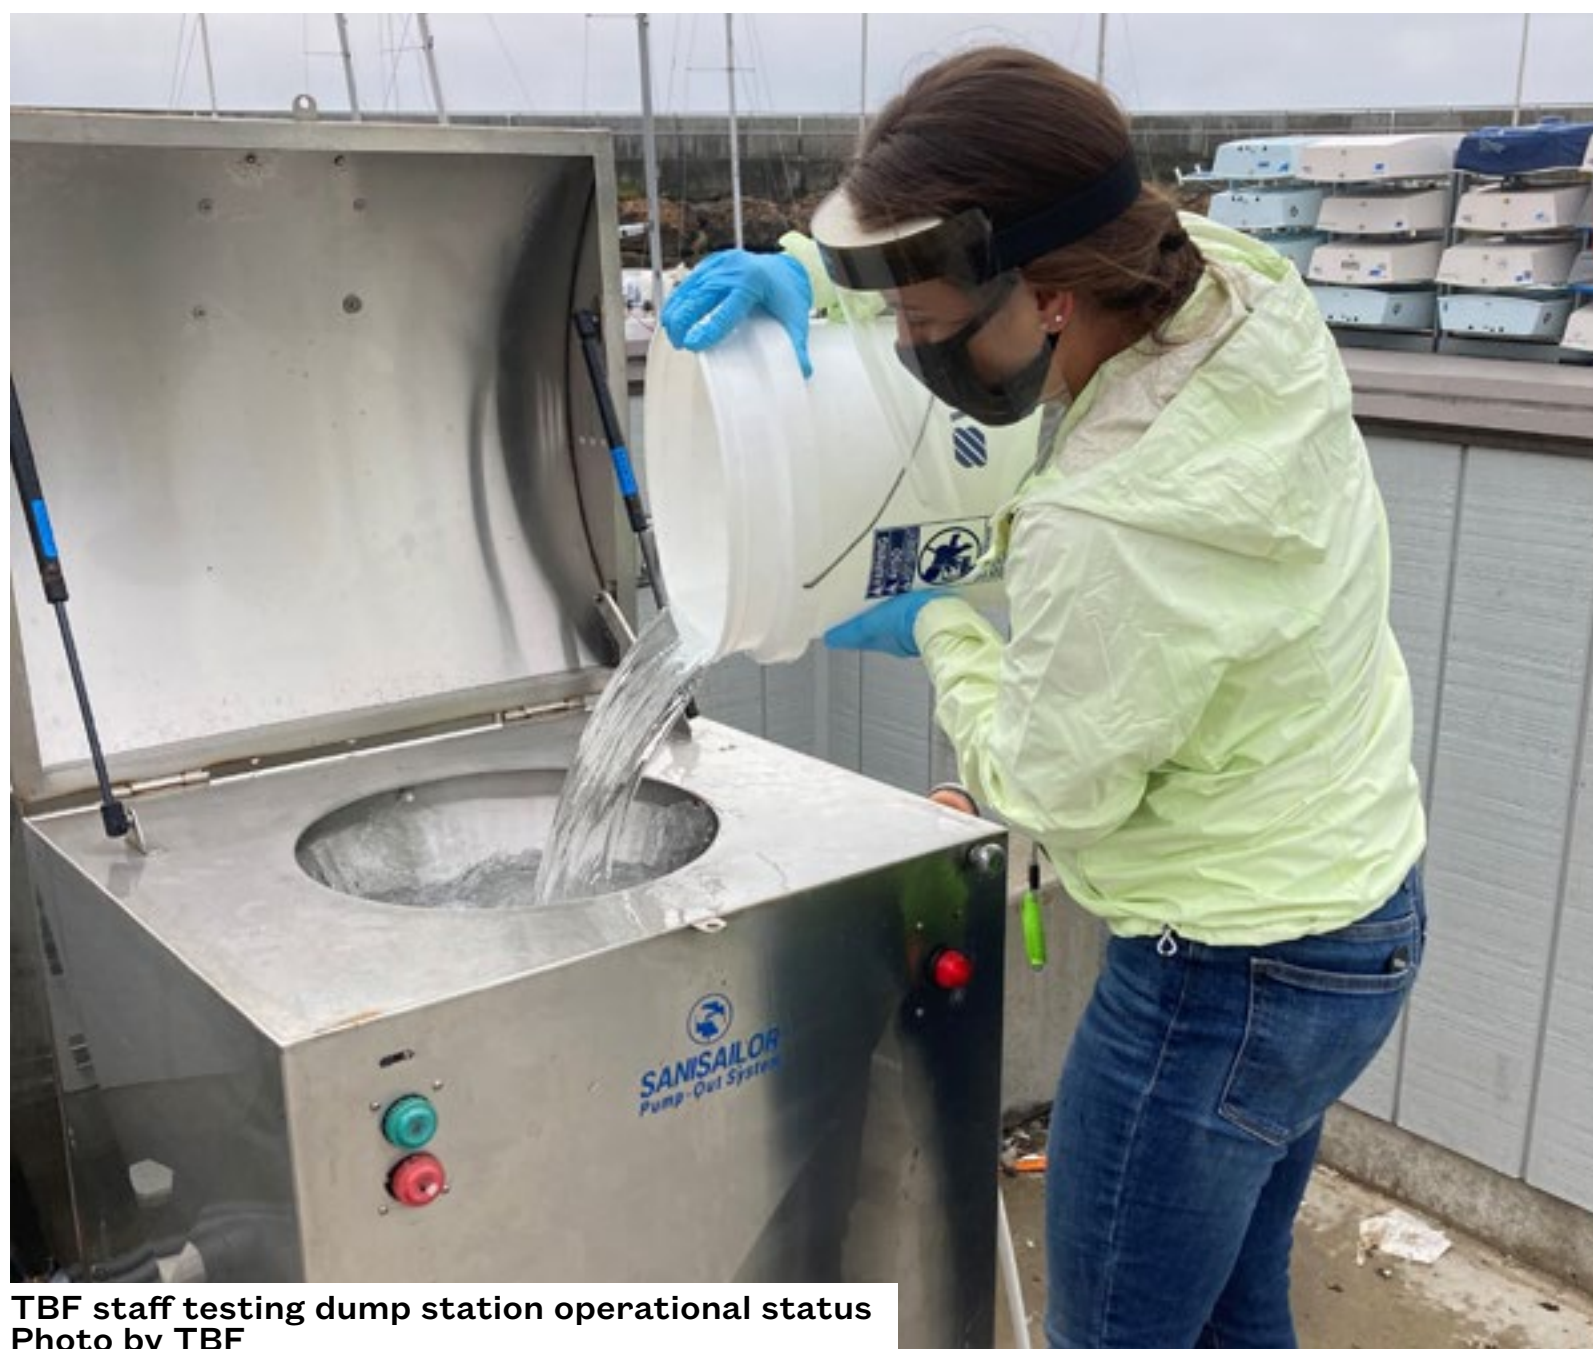
TBF staff testing dump station operational status  
Photo by TBF

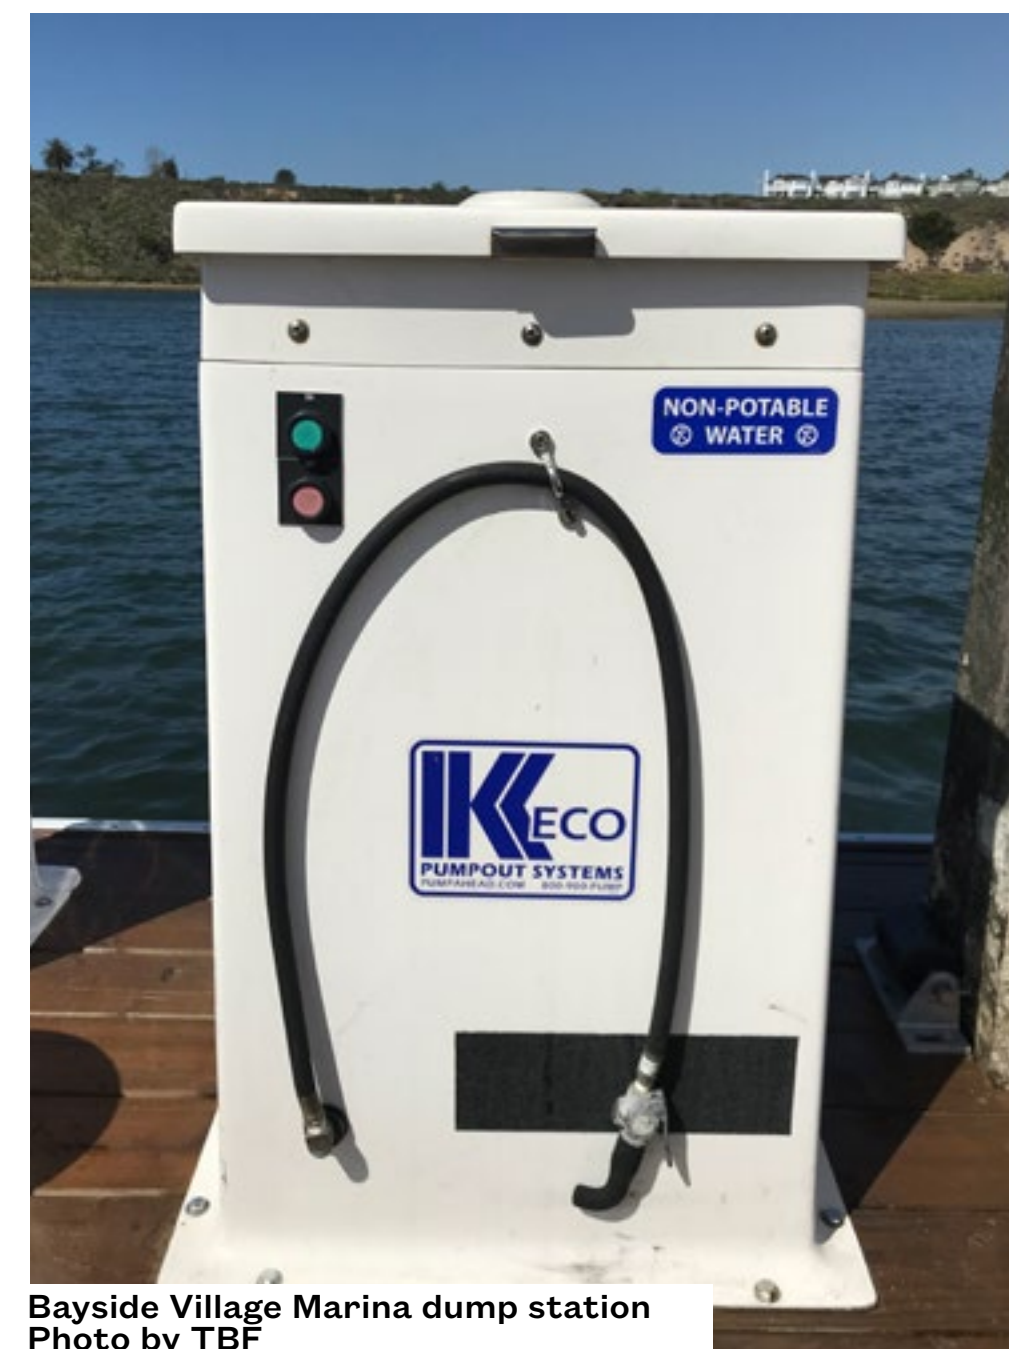
Bayside Village Marina dump station  
Photo by TBF
